Manhole Inspection Summary

Manhole # S45G2_030MH

Insp Date: **1/25/08 9:15 AM**

Location Address: **Pascal Ave.**

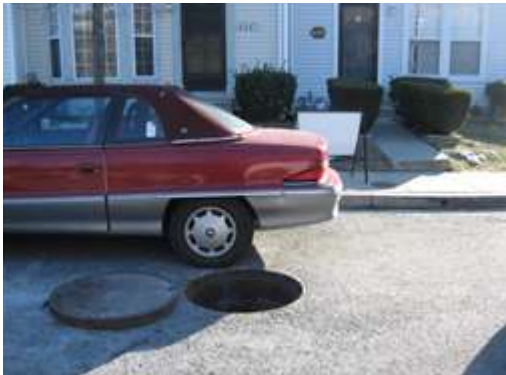
Location View

Pascal Ave.

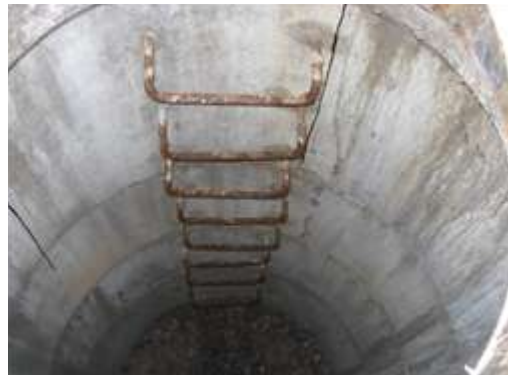
Steps

Count: **8** Missing: **0** ☐ Corroded

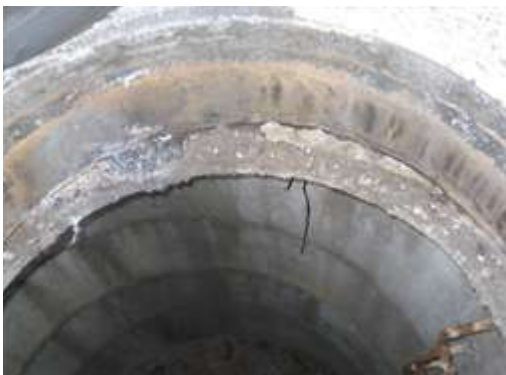
Defect 1

Offset: **3** (in.)

Frame offset

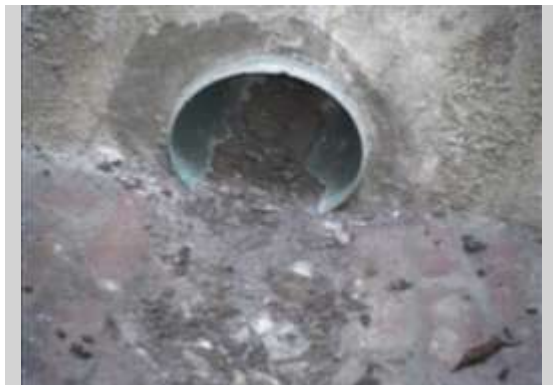
12 O'Clock Outflow

8 in. Circular Gravity Sewer
Pipe Out @ 12 O'Clock

Pipe Height: **9.6** (in.) Rod and Bar (Angled)

Pipe Material: **PVC** ☐ Pipe Lined

Invert Depth: **11.39** (ft.) Flow Characteristics: **None**

Infiltration: **None** Pipe Seal Cond: **Sound**
